**Flood Control Project Maintenance
Levee Inspections****LMA District Cover Sheet****Spring 2013 Levee Inspection Results****Solano County Public Works Mellin Levee**

Spring 2013 Levee Inspection Results

Solano County Public Works Mellin Levee

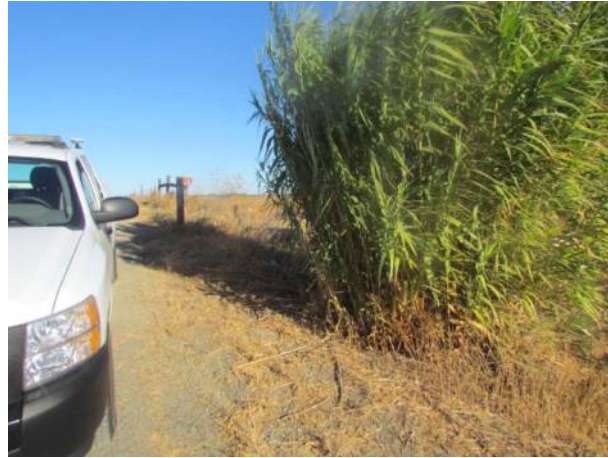
Levee Mile Report Line	4
Start Levee Mile	0.00
End Levee Mile	0.00
Location	Water Side
Category	
Item	Vegetation
Looking west at bamboo on waterside slope.	
richard_s_20130304_160.JPG

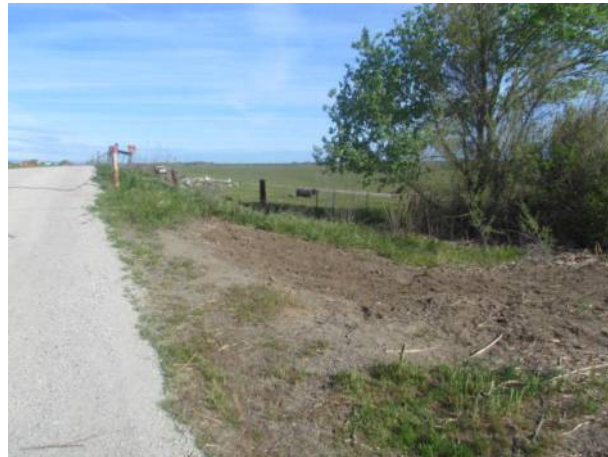
Levee Mile Report Line	4
Start Levee Mile	0.00
End Levee Mile	0.00
Location	Water Side
Category	
Item	Vegetation
Looking west after district removed bamboo on waterside slope at the entrance of the project.	
richard_s_20130402_025.JPG

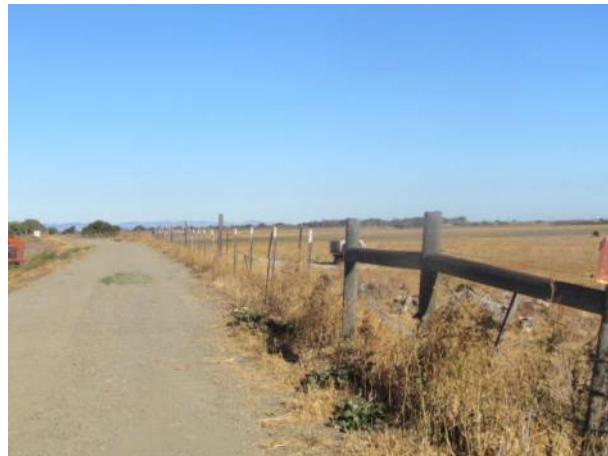
Levee Mile Report Line	7
Start Levee Mile	0.00
End Levee Mile	0.59
Location	Water Side
Category	
Item	Encroachments
Looking west at fence on waterside shoulder.	
richard_s_20130304_161.JPG

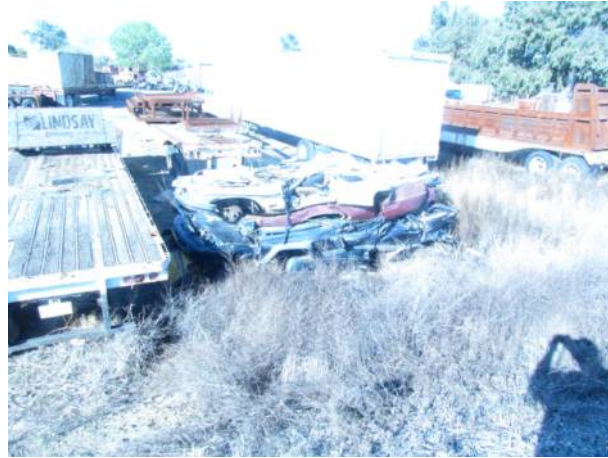
Levee Mile Report Line	8
Start Levee Mile	0.04
End Levee Mile	0.04
Location	Land Side
Category	
Item	Encroachments
Looking south at crushed vehicles at landside toe.(Spring 2012)	
richard_s_20130304_162.jpg

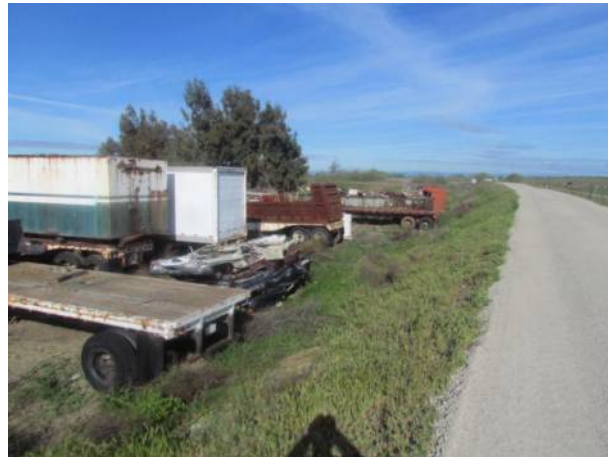
Levee Mile Report Line	8
Start Levee Mile	0.04
End Levee Mile	0.04
Location	Land Side
Category	
Item	Encroachments
Looking west at crushed vehicles and trailers on landside toe.	
richard_s_20130402_026.JPG

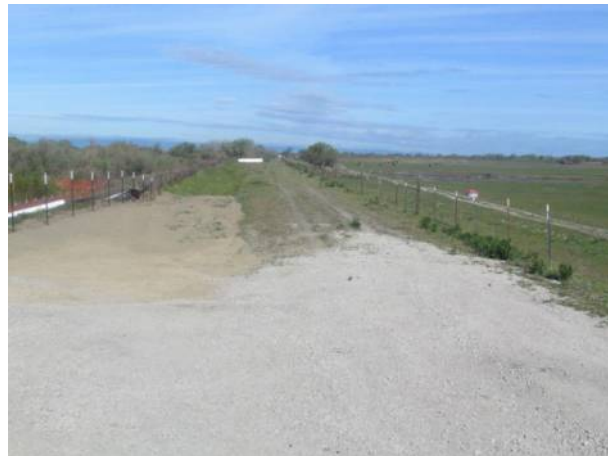
Levee Mile Report Line	10
Start Levee Mile	0.15
End Levee Mile	0.59
Location	Crown
Category	
Item	Crown Surface / Depressions / Rutting
Looking west at crown roadway.	
richard_s_20130402_027.JPG

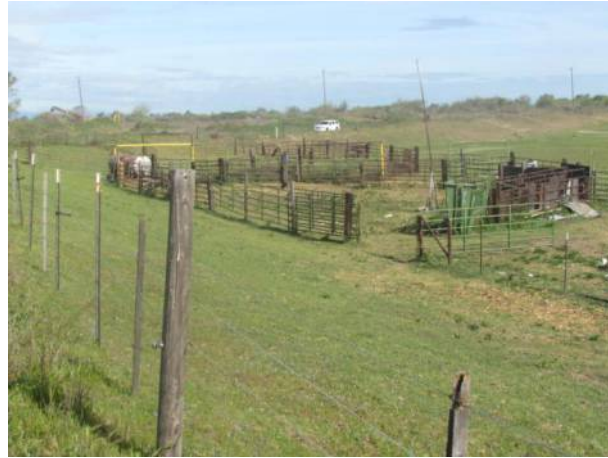
Levee Mile Report Line	11
Start Levee Mile	0.59
End Levee Mile	0.59
Location	Water Side
Category	
Item	Encroachments

DWR ID: DWR_NA0012_01_s_2012_2										
11	0.59	0.59		Encroachments	WS En	M FE : Fence Inspector Comments: Animal corral.	38.180012 ° -121.681943 °	38.180012 ° -121.681943 °	5 Y	
DWR ID: DWR_NA0012_01_s_2012_5

Looking west at animal corral on waterside toe.

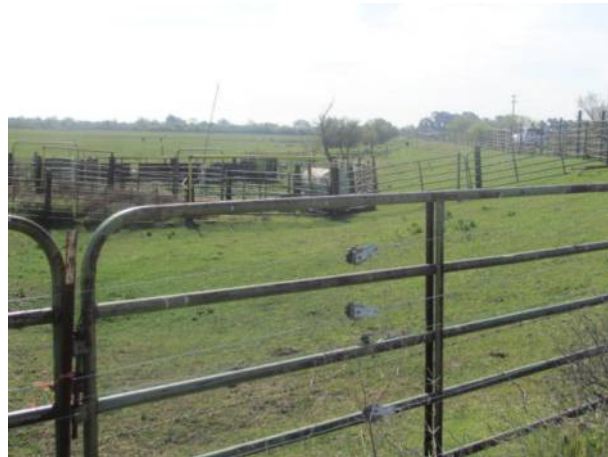
Levee Mile Report Line	11
Start Levee Mile	0.59
End Levee Mile	0.59
Location	Water Side
Category	
Item	Encroachments

Looking east at animal corral on waterside toe.
